CHEVROLET MOTOR DIVISION

Chevrolet Dealer Service Technical Bulletin

67-T-49

Subject: THREE AND FOUR-SPEED FLOOR
SHIFT CONTROL COMPLAINTS
1967 CAMARO

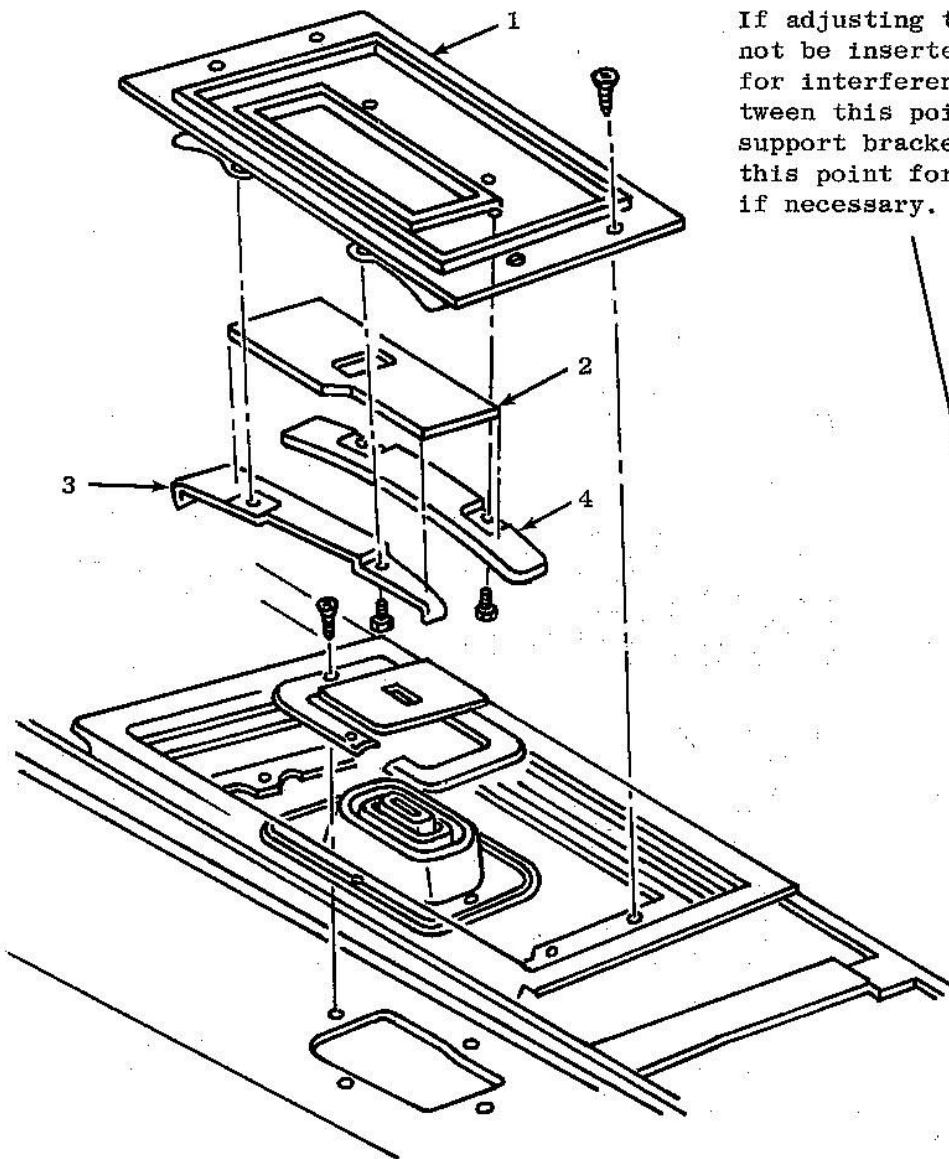
FIGURE 1

This condition is generally caused by the console shifter plastic slide (see fig. #1, item #2) interfering with the left hand retainer (item #3).

For service, remove the plate assembly and examine the underside for interference during operation. If more clearance is needed, add 1/16" washer between the retainer tracks (items #3 and #4) and the plate (item #1). If the slide is too wide, trim off with a file the required amount of material.

Note: A slight application of grease on the edges of the slide, before reassembly, will help reduce and deaden the raspy noise when shifting.

If the slide appears to be damaged at the rear edge of the lever opening, the slide may be acting as a stop for the lever. To correct this condition, remove approximately 3/16" from the slide stop or enlarge the opening in the slide.

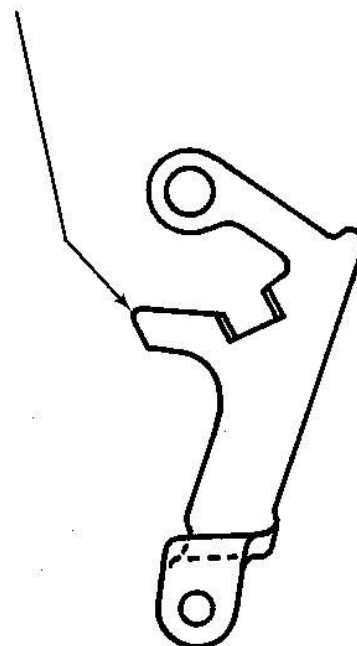
FIGURE 2

If adjusting tool can not be inserted, check for interference between this point - and support bracket, grind this point for clearance, if necessary.

REVERSE LEVER - 4-SPEED

3. Check crossover adjustment - using crossover adjustment tool and procedures, as described in March, 1967, Chevrolet Service News on page 6, check the crossover adjustment. If the tool will not fit (4-speed only), cause may be due to a burr on the front edge of the reverse lever. If the burr is present, remove the lever from the control and grind off the tip of lever (see fig. #2). Make sure all jam nuts and all shift lever bolts are tight.

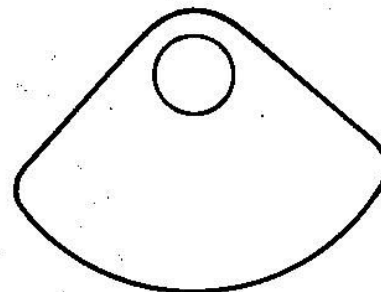
FIGURE 3

ANTI-RATTLE WAVE PLATE

1. Pry off polyurethane retainer and discard.
2. Drive out pivot shaft.
3. Remove levers, wave plate (fig. 3), and lockout plate from bracket (discard wave plate).
4. If reverse inhibitor load is too low, remove plunger and install new plunger (Part No. 3923542) (4-speed only).
5. Inspect shift and control levers for burrs or roughness in gate areas and dress with a stone as required.
6. Lubricate all rubbing surfaces with water resistant grease and reassemble.
7. Install new low load polyurethane retainer (Part No. 3923544).
8. Pry out coil bias spring and discard (4-speeds only).
9. Reinstall control and adjust rods. Be sure to lube rod ends.
