# Engine Dress At St. Louis-Corvette

PLANTING SMALL-BLOCKS DURING ST. LOUIS ASSEMBLY

BY JOHN HINCKLEY

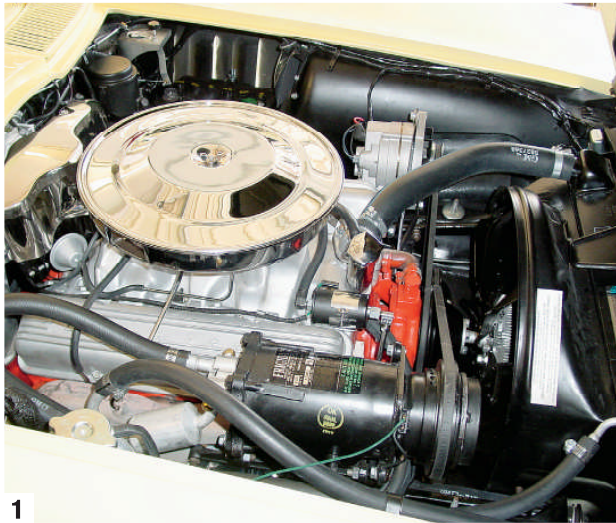
1 A typical fully dressed Corvette engine we're used to seeing. This month's article will show you how it got that way as it came down the engine dress line at St. Louis.

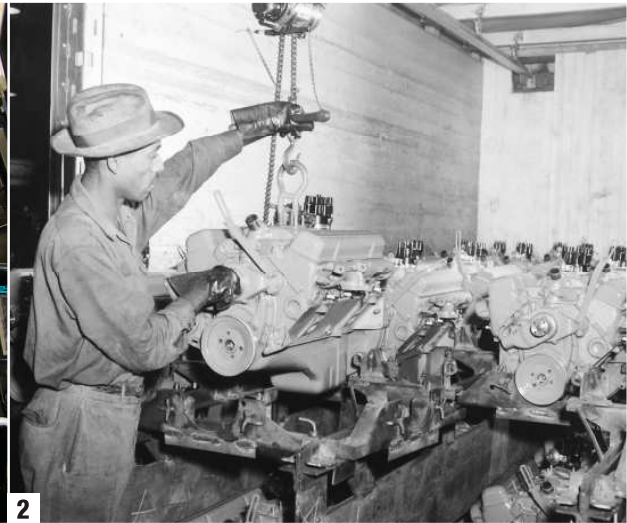
2 Picking up where we left off last month, here's the "naked" engine being shipped from Flint V-8; it came out of the shipping rack at St. Louis and was hung on the engine dress line. (GM Photo)

Those “naked” engines from Flint V-8 came out of the shipping rack and went right on the engine dress line, then into the chassis. There is a common misconception that Corvette engines were run off-line after they were dressed and before they went into the chassis, but that's not the case; there WAS an off-line

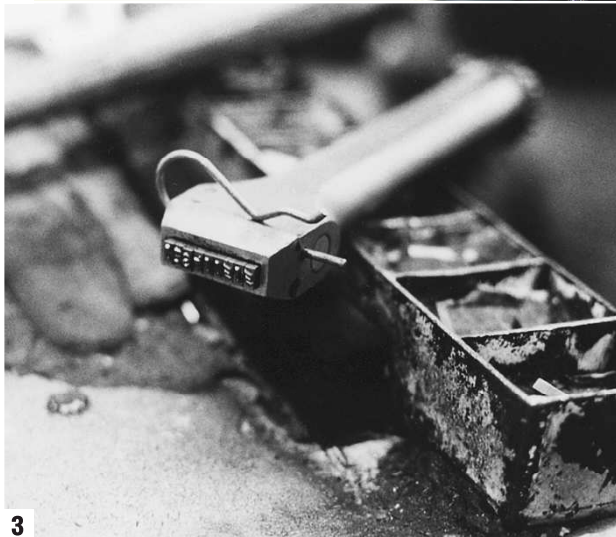
3 This is the St. Louis gang-stamp tool used to stamp the car's VIN derivative on the front block pad. Individual dies were changed for each car's VIN by removing the retaining pin. (Hanson Photo)

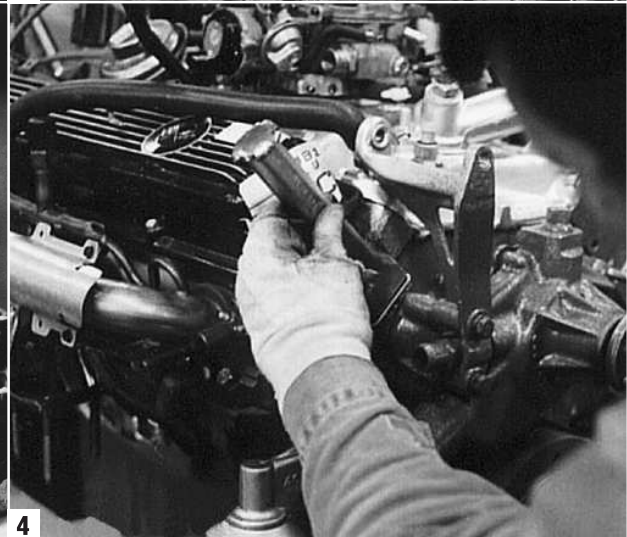
4 Positioning the gang-stamp tool on the front block pad prior to whacking it with a 3-pound sledge. The same operator stamped the transmission with the same tool. (Hanson Photo)

After lubing and installing the throwout bearing (on manuals), the transmission was installed. On a Powerglide, the converter bolts were driven while the flexplate was turned by an air-powered dummy starter tool, and the inspection cover was installed. At this point, beginning in mid-1960, the six-digit

VIN derivative for that car was stamped on the front engine pad. This became a seven-digit number in 1961, with the first digit being the model year, and this VIN derivative number was also stamped on the transmission.

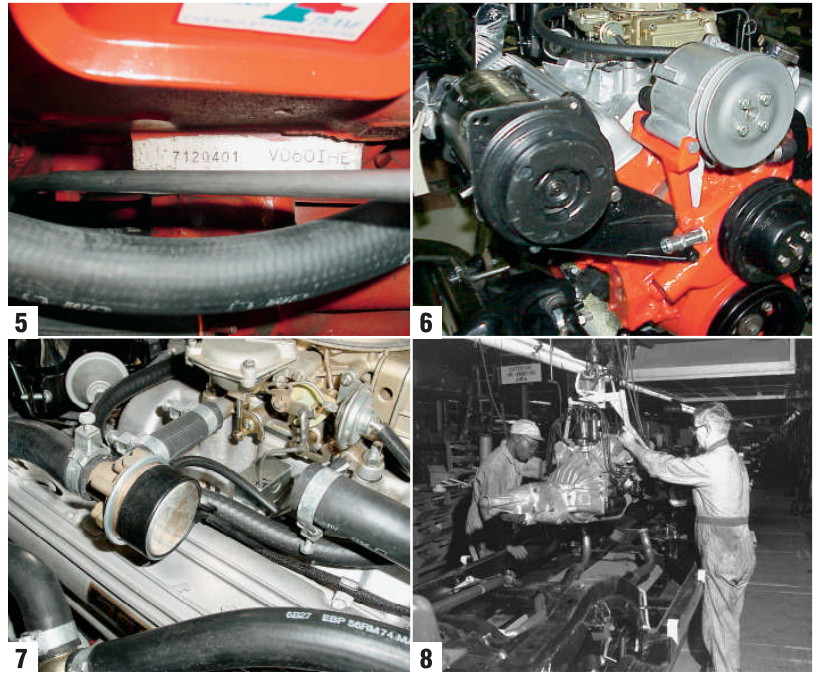
5 A typical pad after stamping; the Flint Engine stamp on the right, and the St. Louis VIN derivative stamp on the left.

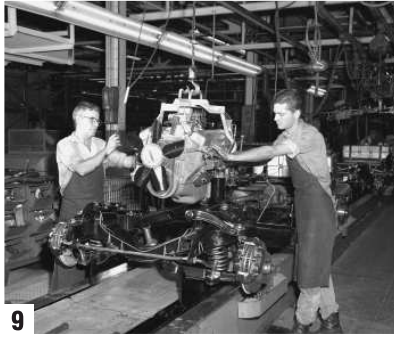
**9** A 1966 L-79 engine positioned for drop on the chassis line. Note shim count markings at the front of the frame horn. (GM Photo)
