CHEVROLET MOTOR DIVISION

Chevrolet Dealer Service Technical Bulletin

67-T-49

Subject: THREE AND FOUR-SPEED FLOOR
SHIFT CONTROL COMPLAINTS
1967 CAMARO

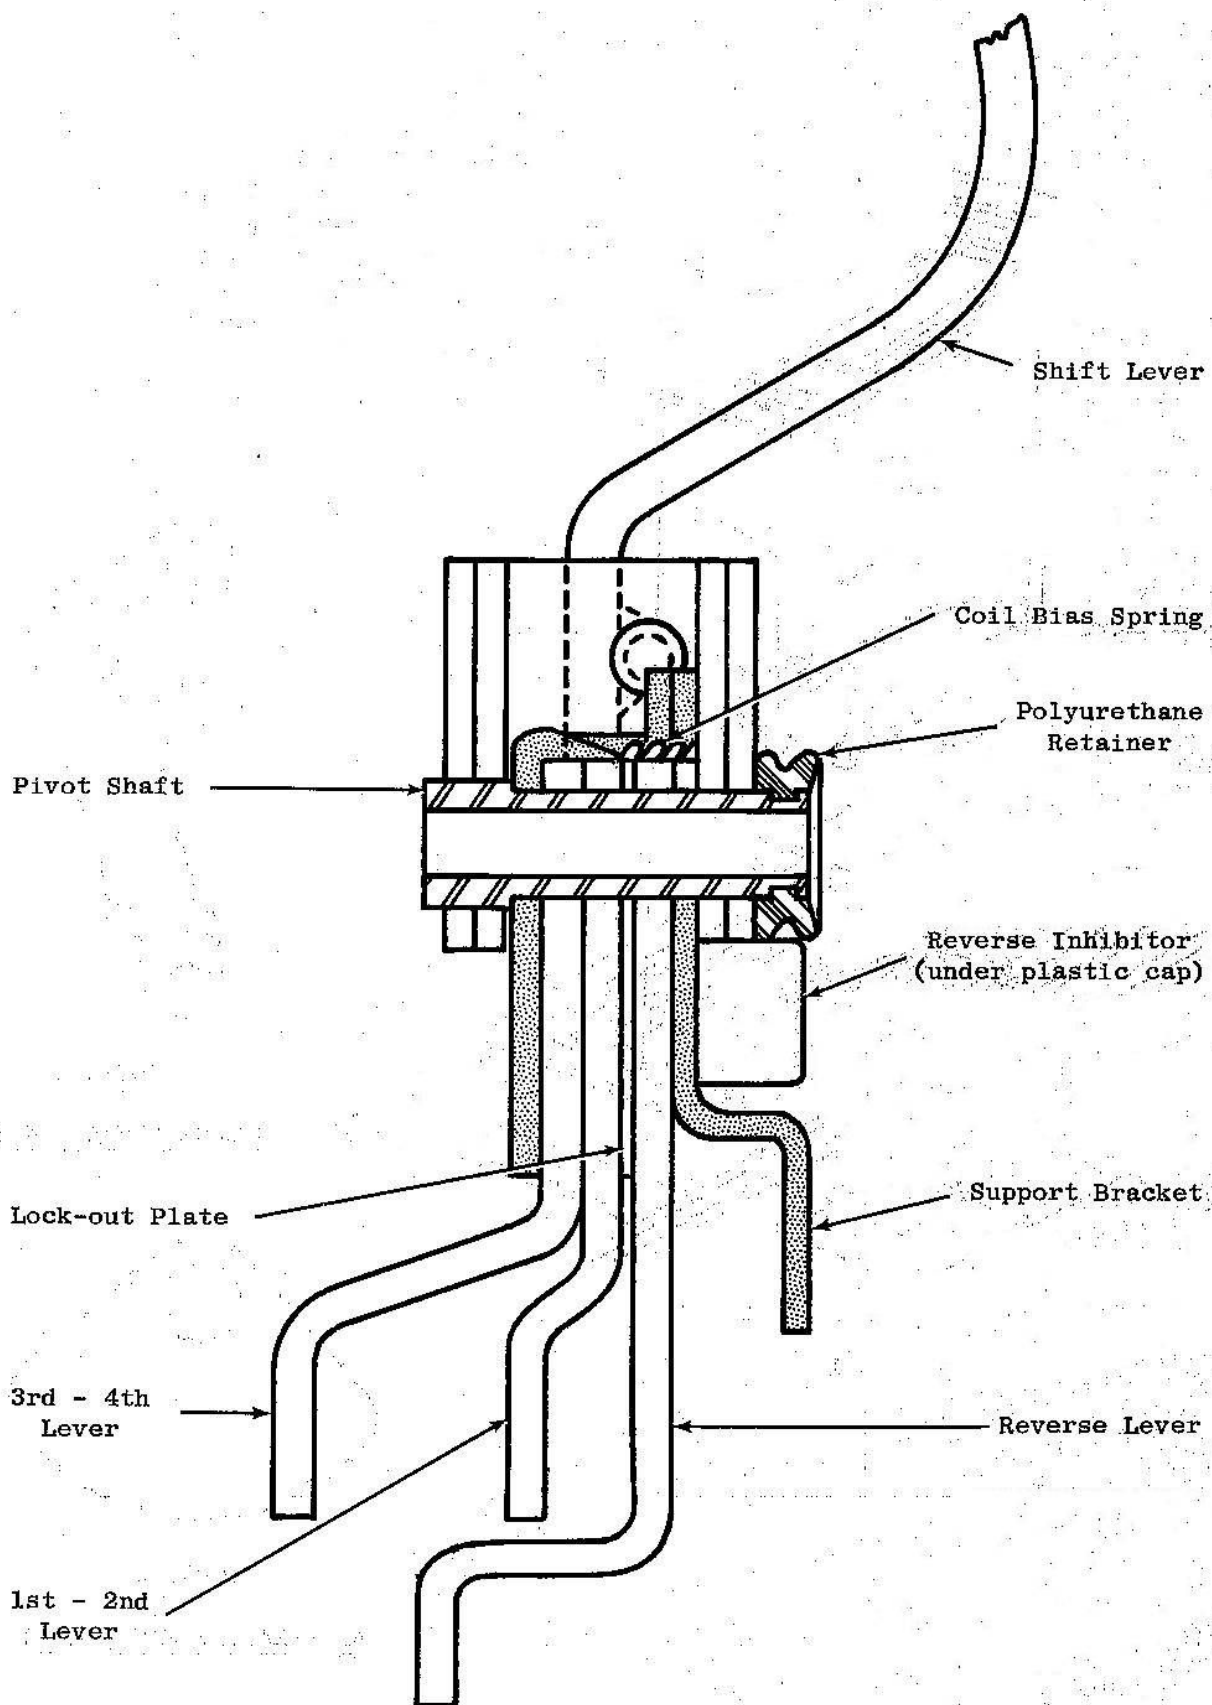
FIGURE 3

1. Pry off polyurethane retainer and discard.
2. Drive out pivot shaft.
3. Remove levers, wave plate (fig. 3), and lockout plate from bracket (discard wave plate).
4. If reverse inhibitor load is too low, remove plunger and install new plunger (Part No. 3923542) (4-speed only).
5. Inspect shift and control levers for burrs or roughness in gate areas and dress with a stone as required.
6. Lubricate all rubbing surfaces with water resistant grease and reassemble.
7. Install new low load polyurethane retainer (Part No. 3923544).
8. Pry out coil bias spring and discard (4-speeds only).
9. Reinstall control and adjust rods. Be sure to lube rod ends.

ANTI-RATTLE WAVE PLATE
